COAL MINE SAFETY AND HEALTH  
AMENDED REPORT OF INVESTIGATION

Fatal Fall of Roof Accident (Amended)  
March 29, 2006  
(Victim Died April 10, 2006)

No. 4 Mine  
Jim Walter Resources, Inc.  
Tuscaloosa County, Alabama  
I.D. No. 01-01247

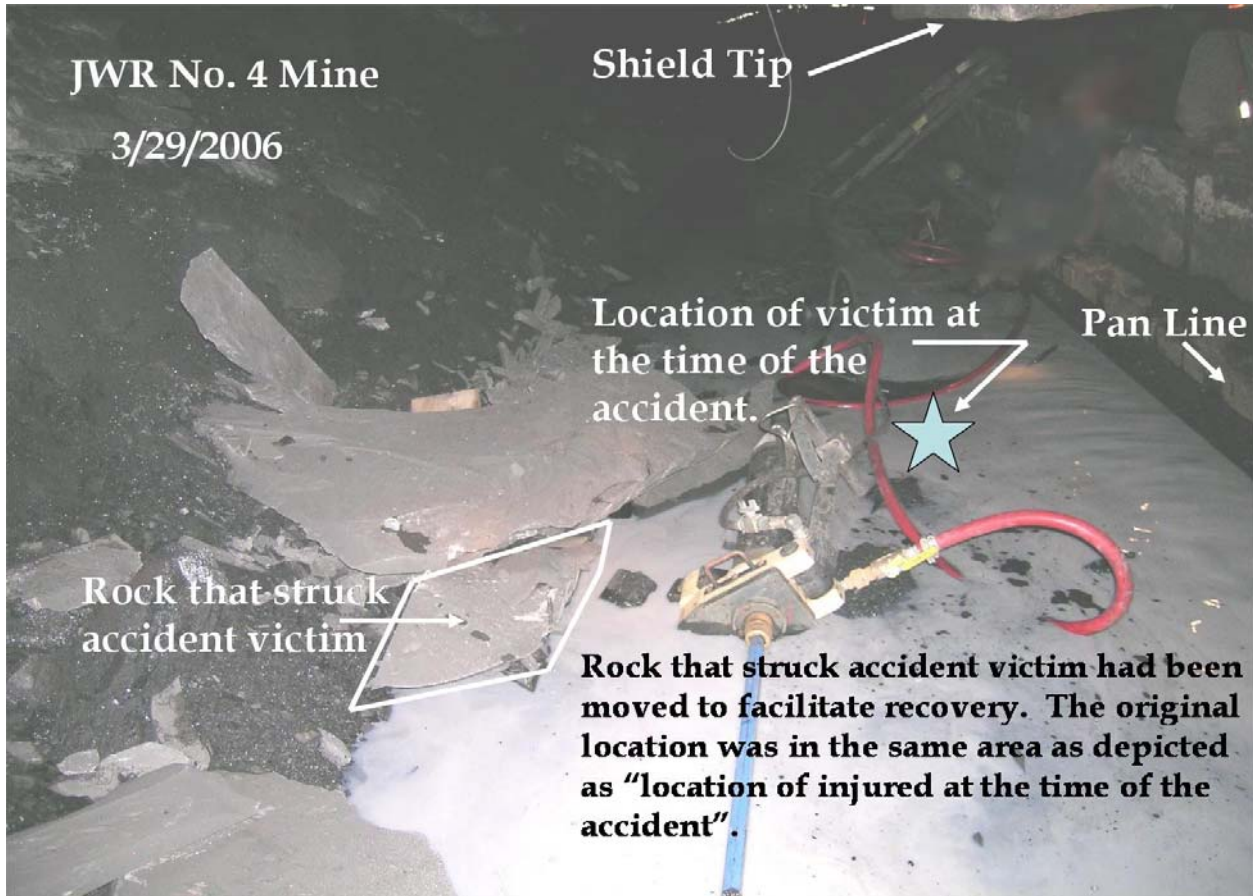
At approximately 11:25 a.m. on March 29, 2006, a miner received injuries that resulted in his death on April 10, 2006. The victim was installing roof bolts between the shield tips and the longwall face in preparation for moving the longwall mining equipment. The victim was located at the outer edge of a shield tip while preparing to drill, when a piece of roof rock fell. He was hit by the rock, which caused him to fall, striking his head against the pan-line. The victim had worked at the Jim Walter Resources, Inc. No. 4 Mine for 23 years.

The accident occurred because the mine operator's procedures for roof bolting along the longwall face were not adequate.
